# Release Notes for the Catalyst 3750, 3560, 2975, and 2960 Switches, Cisco IOS Release 12.2(52)SE

Cisco IOS Release 12.2(52)SE runs on all Catalyst 3750, 3560, 2975, and 2960 switches and on Cisco EtherSwitch service modules.

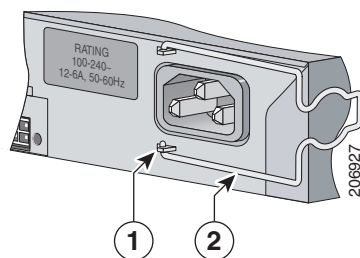
**Figure 1-1** Rotate the Retainer Wire

- Step 1** To install the retainer wire into the lance loops, rotate it to the right of the AC power cord connector.

1	Lance loop
2	Retainer wire

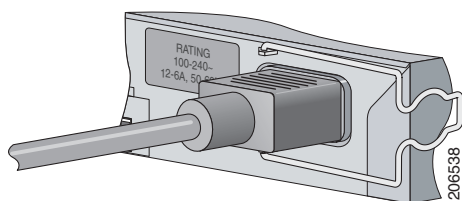
**Figure 1-2** *Insert the AC Power Cord*

**Step 2** Keeping the retainer wire to the right side, insert the AC power cord.

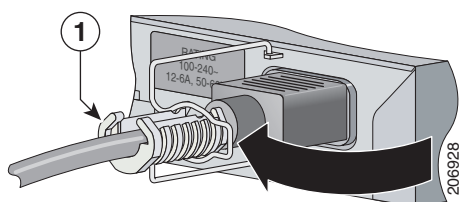
**Figure 1-3** *Attach the Power Cord Bushing*

**Step 3** Place the power cord bushing on the power cord with the opening at the top. Move the retainer wire into place as shown. The bushing has only one slot for the retainer wire. Move the retainer wire into the slot.

<b>1</b>	Power cord bushing
----------	--------------------

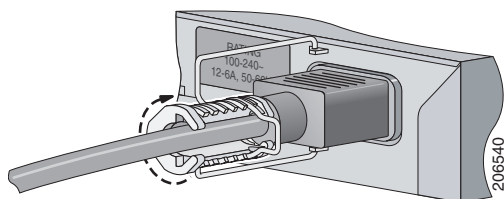
**Figure 1-4** *Rotate the Bushing Clockwise*

**Step 4** Slide the bushing so that it rests against the power-cord connector, and then rotate the bushing clockwise until the bushing is securely fastened and its opening is on the right side of the power cord.

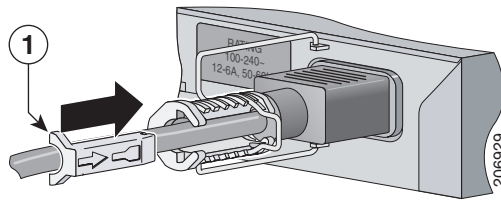
**Figure 1-5** *Insert the Securing Clip*

- Step 5** Insert the securing clip in the opening of the bushing with the arrow pointing towards the switch.

1	Securing clip
---	---------------

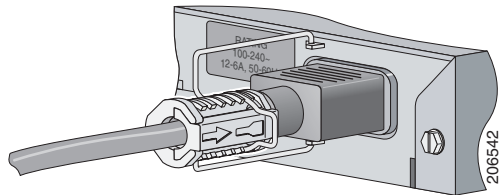
**Figure 1-6** *Verify the Connection*

- Step 6** Make sure that the power cord connection looks like this.
